SECTION 7. DESCRIPTION OF RECOMMENDED ALTERNATIVE

7.1 DESCRIPTION OF THE RECOMMENDED PLAN

The recommended plan for ecosystem restoration of the 2.5-mile Mill River corridor in Stamford, Connecticut has the following restoration measures:

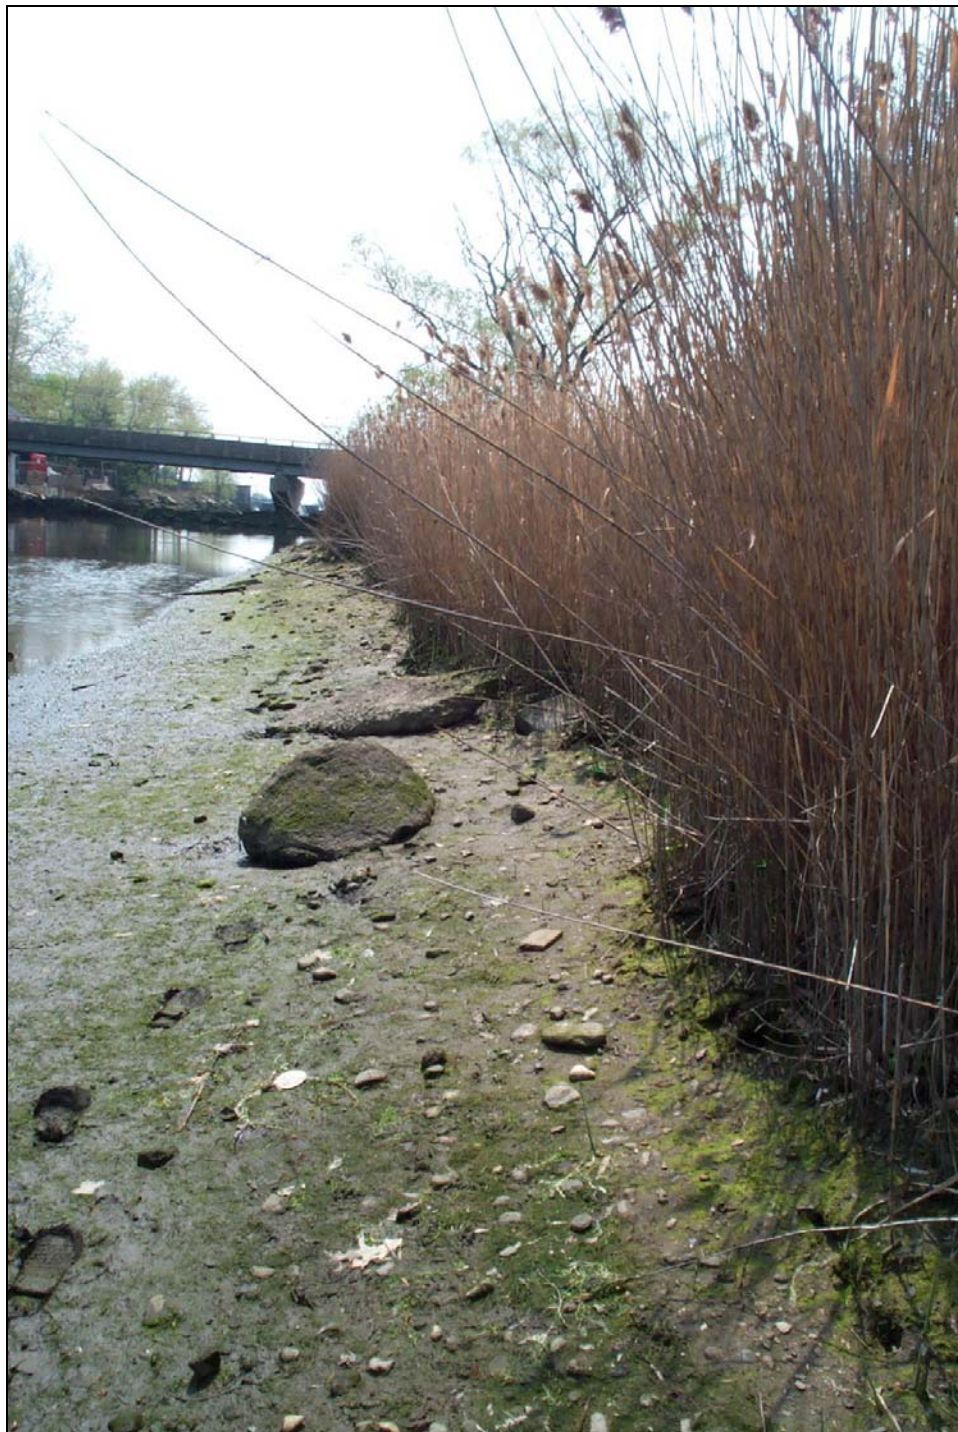
**Plate 7. Area dominated by *Phragmites*
within tidal reach of Mill River**

Two sites for tidal wetland restoration are found south of the Main Street Dam. These areas are both approximately 0.4 acres in size, are currently dominated by *Phragmites*, and provide little habitat value (Plate 7).

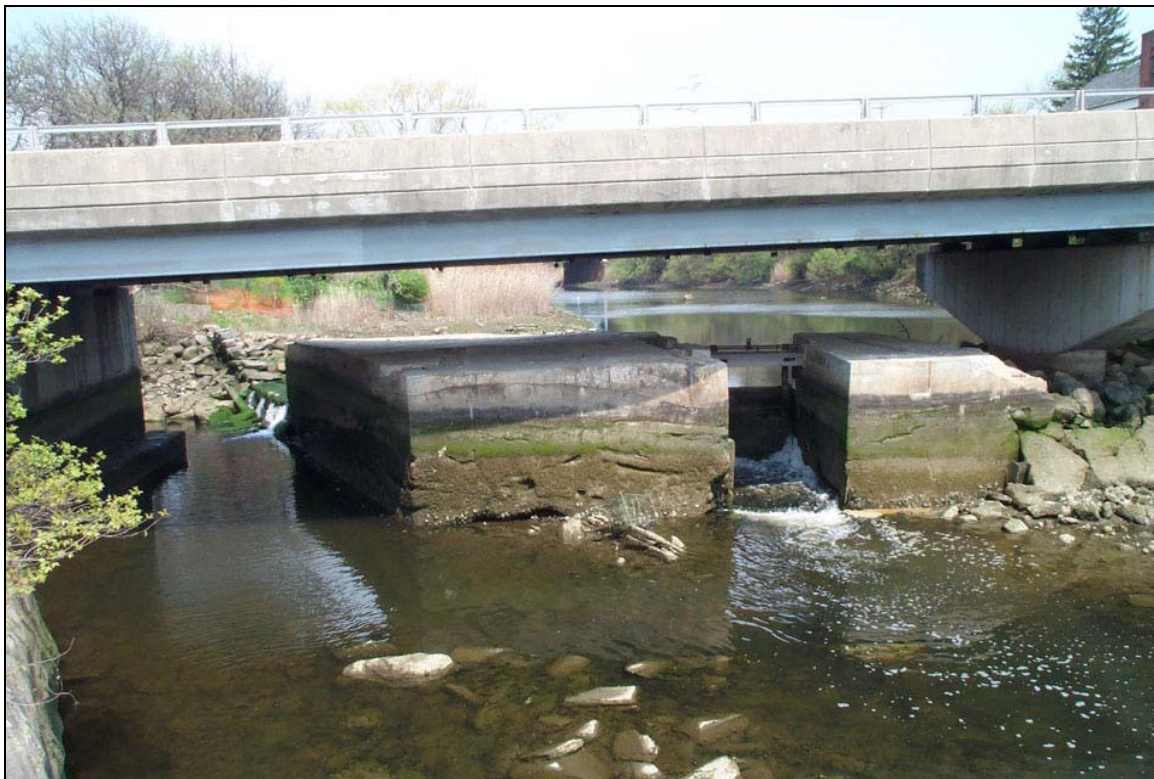
Plate 8. Concrete obstruction under Pulaski Street Bridge on the Mill River in Stamford, CT. This abandoned structure blocks fish passage during mid and low tides.

Currently, a large concrete platform and abandoned weir structure exist under and slightly upstream of Pulaski Street Bridge (see Plate 8). The affected reach of channel is approximately 300 feet. This structure becomes a complete impediment to fish passage during mid to low tides, so anadromous fish and other aquatic species have limited upstream passage only during high tides. The recommended plan includes removal of all of the abandoned structure in the river and restoring the natural stream channel through the affected reach. The construction requires staging area setup along the channel's edge, demolition of the concrete structure (estimated 556 cubic yards), and hauling and disposal of the concrete at a suitable location selected by the city of Stamford.
